Enhancing the upstream passage of river lamprey at a microhydropower installation using horizontally-mounted studded tiles

Jeroen S. Tummers^a, James R. Kerr^b, Pat O'Brien^c, Paul Kemp^b, Martyn C. Lucas^a

Abstract

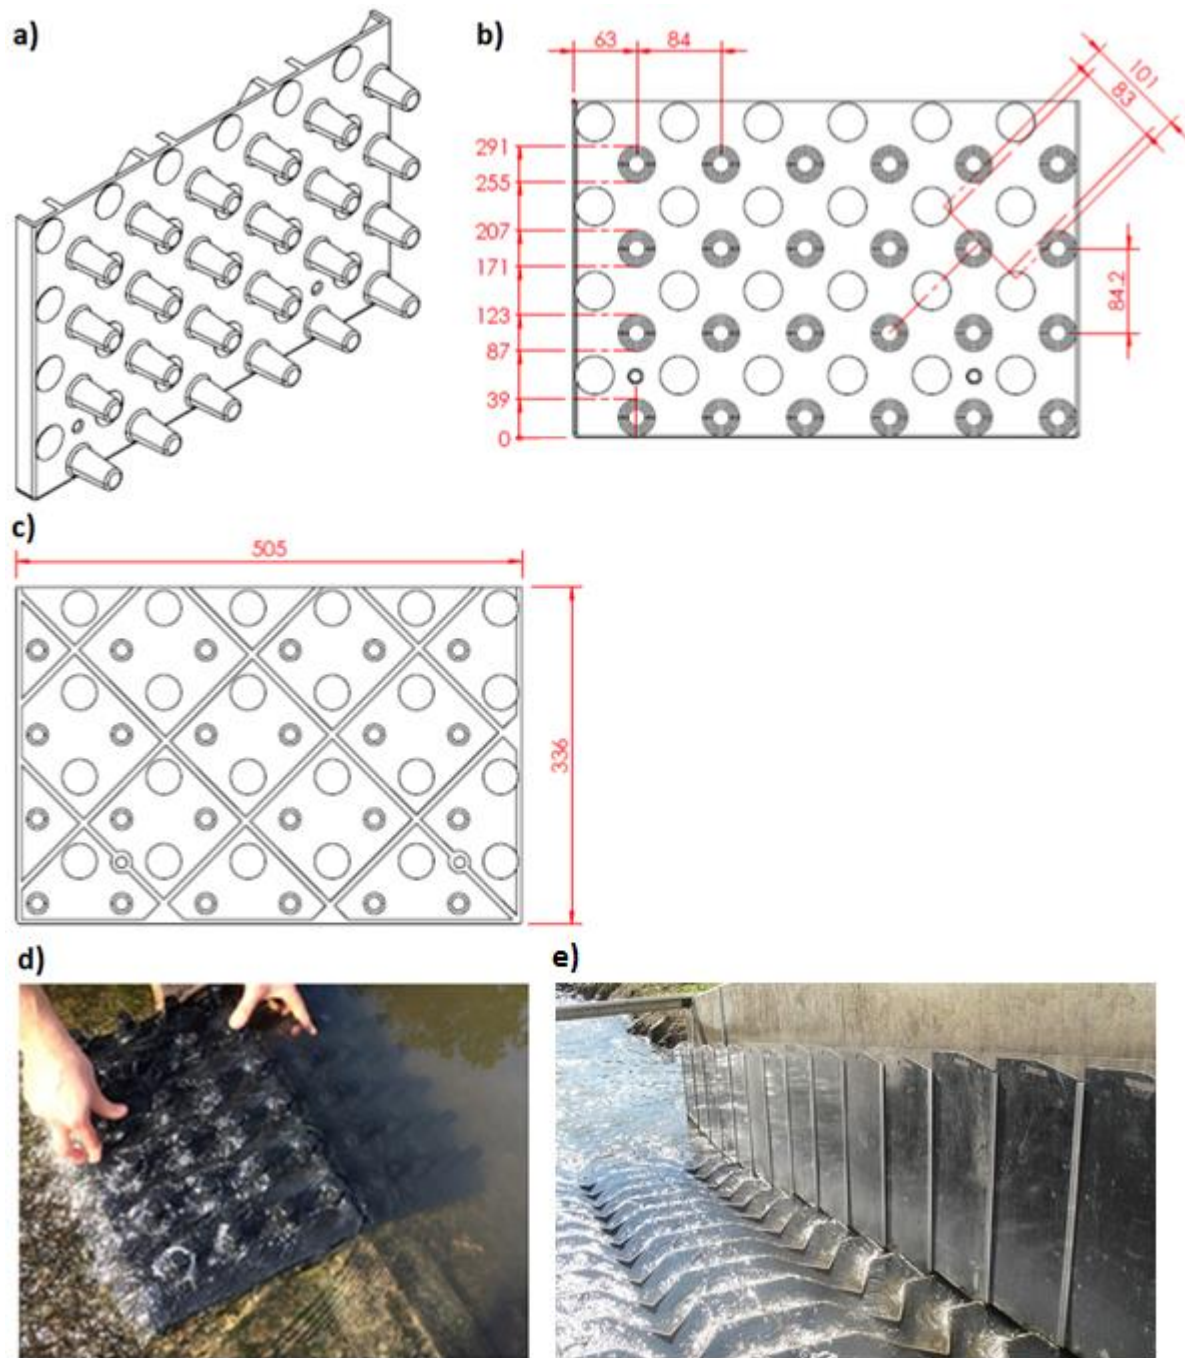
Figure 1: **a), b), c)** Oblique, top-down and reverse view, respectively, of a studded tile as used in the current study, showing relevant dimensions (drawings obtained from <http://www.berryescott.co.uk/wp-content/uploads/2016/08/lamprey-tile-drawing.png>). Fully open circles represent studs cut off (presenting a flat surface for lamprey to attach to) during commercial production to provide Berry and Escott ‘lamprey tile’ specification; **d)** Initial placements of studded tiles on the weir face. Shown is the weir crest under very low flow (*ca.* Q_{95}) conditions, with one tile fixed on the upstream face and one on the downstream face. No further tiles were placed at the upstream side (extending over the weir crest by 0.5 m), while the tiles were fixed continuously on the downstream face up to 0.4 m from the downstream weir limit; **e)** Identical studded tiles but mounted vertically within the SAB fishway, with studs projecting laterally (continuously along right wing wall, shown is the mostly dewatered fishway while construction was ongoing), as evaluated in Tummers *et al.* (2016).

Identical single-density tiles were also used in the current study, but fixed horizontally directly on the weir face (*Figure 1d*), near the right bank in the manner indicated in Vowles *et al.* (2017). A 1 m wide continuous route of tiles was installed, starting 1 m away from the right wing wall of the weir. This route was on the same side of the weir as the fishway and the turbine tailrace, as

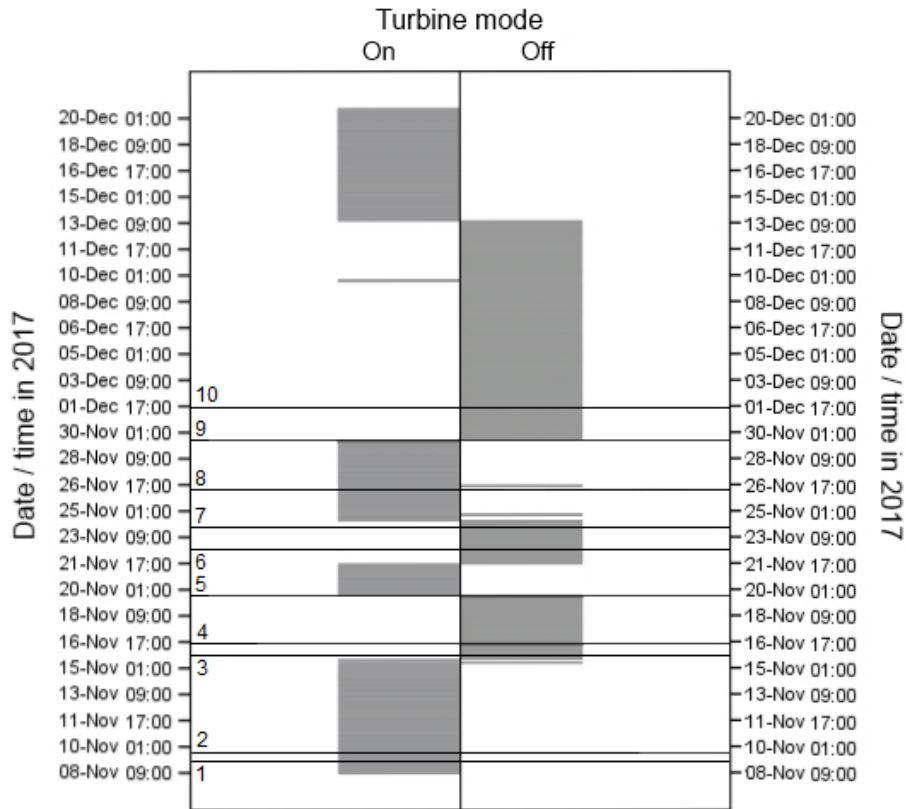
Figure 2: Turbine operation during the study period. Date and time of river lamprey batch releases are presented as horizontal lines and batch numbers are indicated adjacent to each line.

In September 2017 a microhydroelectric power station, consisting of two horizontally-placed Kaplan turbines (nominal power output 50 kW per turbine) became operational on the right bank of Buttercrambe weir. However, due to mechanical failure only one turbine was functional during the study period. No tailrace screens were in place. The turbine running regime at the site is flow-controlled (conditions set by the Environment Agency [EA]): a head difference over the weir outside the range of 0.390 - 0.750 m prevents turbine operation. Manual power-up and shutdown of the turbine was possible during the study, provided head difference was appropriate. Turbine-on and turbine-off conditions were maintained for 21/43 (48.8%) and 22/43 (51.2%) days of the study period, respectively, during which 395 lamprey were released (150 and 245 under turbine-on and -off conditions, respectively; *Figure 2*).

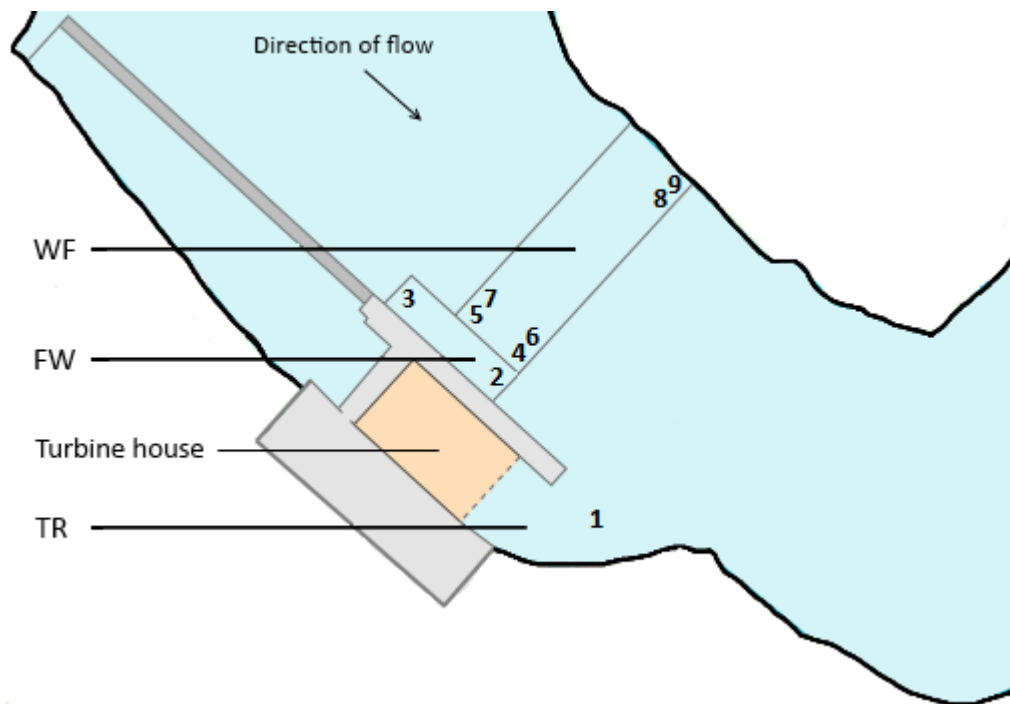
Figure 3: Study site showing the turbine tailrace (TR, with antenna 1), bottom-baffle fishway (FW, antennas 2 and 3) and the Crump weir (WF, weir face; antennas 4 and 5 [controls right bank], 6 and 7 [tiled route] and 8 and 9 [controls left bank]).

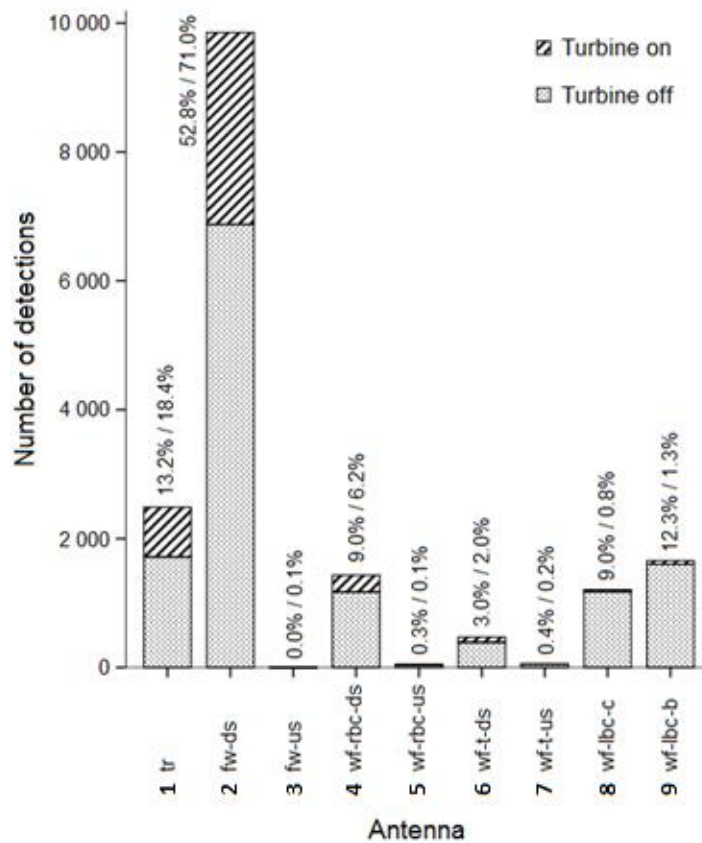
Figure 4: Total number of detections logged at each of the PIT antennas ($n = 9$) under ‘turbine off’ (shaded columns) and ‘turbine on’ (striped diagonal columns) conditions. Proportion of total attempts under turbine off / on conditions is shown on top / under the stacked column. tr: tailrace; fw-us/ds: fishway upstream/downstream; wf-lbc-b: weir face left-bank control bank-side; wf-lbc-c: weir face left-bank control channel-side; wf-t-us/ds: weir face tiled upstream/downstream; wf-rbc-us/ds: weir face right-bank control upstream/downstream. Numbers below antennas correspond to antenna locations as shown in *Figure 3*.

When the turbine was operating, most detections were logged at the downstream entrance of the fishway (2976/4190 [71.0% of total attempts under turbine-on condition]), while, under the same turbine condition, only 82 attempts (2.0%) were logged at the tiled route downstream entrance (*Figure 4*). A higher number of detections were recorded at the downstream end of the neighbouring control route during turbine-on ($n = 259$ [6.2%]). Lamprey were attracted towards the right half of the channel when the turbine was running, as only $n = 88/4190$ (2.1% of total attempts when turbine on) detections were made at the two left-bank control antennas in the turbine-on condition, compared to 2775/13029 (21.3%) at the same two antennas when the turbine was off. The number of lamprey detected at each antenna and attempts per lamprey was higher in the turbine-off condition (*Table 2*; Wilcoxon signed rank test: $Z = -2.407$, $p = 0.016$ and $Z = -2.240$, $p = 0.025$, respectively. Detection range efficiency tests showed no difference between the turbine on/off condition). Fewer PIT detections were logged at the turbine tailrace and fishway entrance, respectively, when the turbine was on ($n = 770$ and $n = 2976$; median [range] river flow turbine-on: 18.7 [$10.5 - 36.3$] $\text{m}^3 \text{s}^{-1}$) compared to off ($n = 1716$ and $n = 6876$; flow: 36.2 [$10.4 - 52.3$] $\text{m}^3 \text{s}^{-1}$; *Table 2*). While water temperature was not different between the turbine operating conditions (on/off; $Z = -0.330$, $p = 0.741$), river flow was lower when the turbine was running than when it was not (median [range] river flow turbine-on: 18.7 [$10.5 - 36.3$] $\text{m}^3 \text{s}^{-1}$, turbine-off flow: 36.2 [$10.4 - 52.3$] $\text{m}^3 \text{s}^{-1}$, $Z = -28.678$, $p < 0.001$).

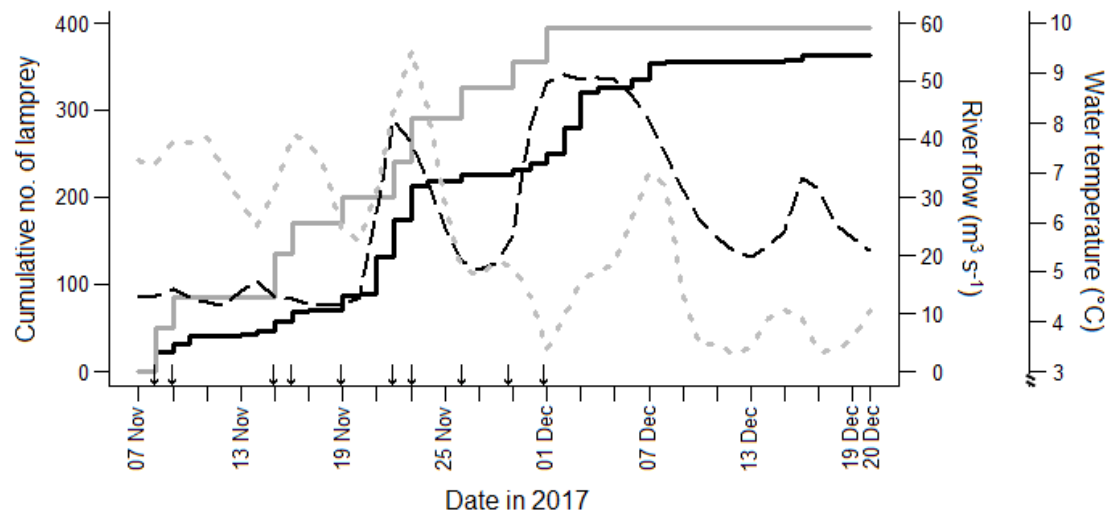
Figure 5: Cumulative number of lamprey released (solid grey) and detected (solid black, both left-side y-axis) at any antenna, river flow ($\text{m}^3 \text{ s}^{-1}$; dashed black; inner right y-axis) and water temperature ($^\circ\text{C}$; dotted grey; outer right y-axis). Arrows indicate time of release on respective dates.

Lamprey were logged as having ascended the tiled route under high flow conditions only (median [range] Q values: Q_7 [$Q_4 - Q_{17}$], flow mean \pm SD: $44.43 \pm 8.85 \text{ m}^3 \text{ s}^{-1}$; over the whole study period: Q_{23} [$Q_4 - Q_{55}$], $26.02 \pm 13.25 \text{ m}^3 \text{ s}^{-1}$). Of all the individuals that passed the weir using the tile route ($n = 44$), 29 (65.9%) did so on 22 November 2017, which coincides with the first high flow event recorded during the study period (Figure 5). Lamprey were detected at the tailrace and fishway entrances under a wide variety of flow conditions (median [range] Q values: Q_8 [$Q_4 - Q_{55}$], flow mean \pm SD: $36.13 \pm 11.85 \text{ m}^3 \text{ s}^{-1}$ for the tailrace and Q_8 [$Q_4 - Q_{55}$], $37.11 \pm 10.65 \text{ m}^3 \text{ s}^{-1}$ for the fishway, respectively). Out of all release days, lowest mean daily flow ($\text{m}^3 \text{ s}^{-1}$) was recorded for batch #5 (19 Nov; $11.3 \text{ m}^3 \text{ s}^{-1}$, Q_{55}), while highest mean release day flow was on 01 Dec (batch #10; $49.8 \text{ m}^3 \text{ s}^{-1}$, Q_4 ; Figure 5). Tested separately, there was an effect of river flow but not water temperature (mean \pm SD over the whole study period: $5.61 \pm 1.66 \text{ }^\circ\text{C}$) on daily number of detections totalled for all antennas, excluding release days (ANOVA: $F_{1,43} = 13.706$, $p = 0.001$ and $F_{1,43} = 2.448$, $p = 0.125$, respectively). Considered together, river flow and water temperature had a positive effect on number of detections (multivariate mixed models: $F_{2,43} = 18.169$, $p = 0.008$). Nearly all (321/363 - 88.4%) first detections of tagged lamprey were made from the start of the study until 2 days after the last release (08 Nov until 03 Dec - 60.5% of the study period), after which (04 Dec - 20 Dec - 39.5% of the study period) few new lamprey ($n = 42/363$ - 11.6%) were detected at any antenna (Figure 5).

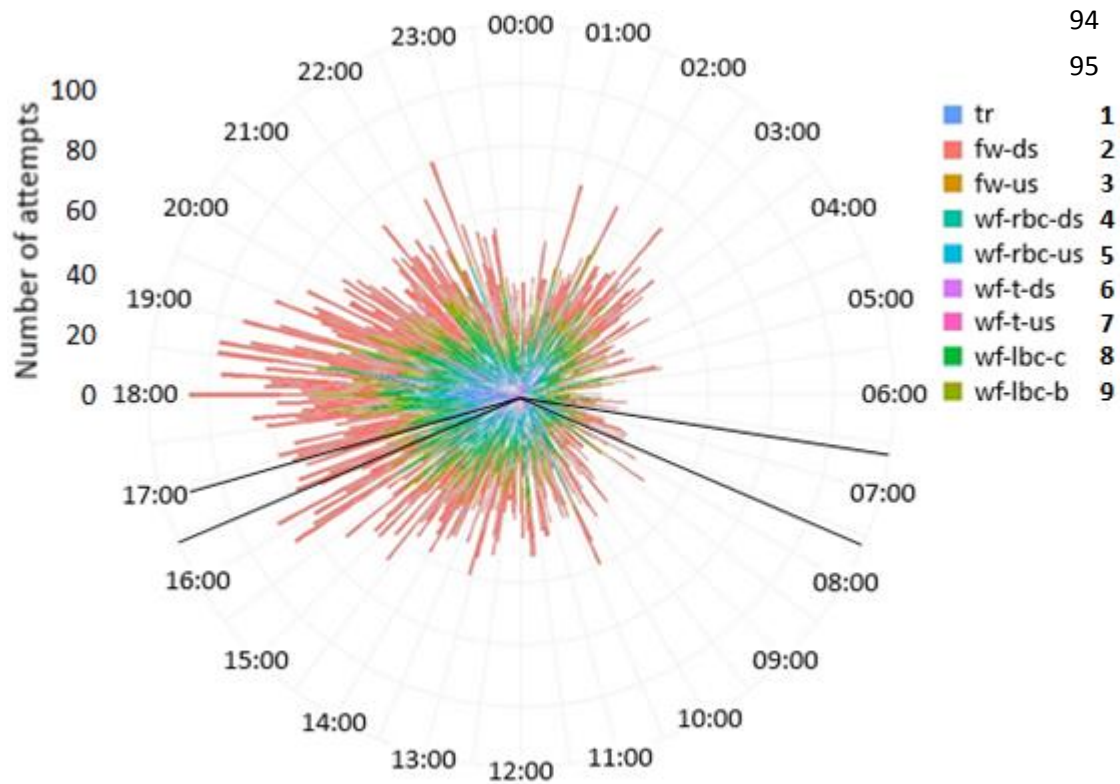
Figure 6: Total number of attempts (stacked) for all detected lamprey at each of the PIT antennas ($n = 9$) in relation to time of day. Morning and evening civil twilight times (06:40 to 16:53 at study start, 07:36 to 16:26 at study end) at Buttercrambe are indicated by black lines. fw-ds/us: fishway downstream/upstream; wf-lbc-b: weir face left-bank control bank-side; wf-lbc-c: weir face left-bank control channel-side; wf-rbc-ds/us: weir face right-bank control downstream/upstream; tr: tailrace; wf-t-ds/us: weir face tiled downstream/upstream. Numbers next to antennas correspond to antenna locations as shown in *Figure 3*.

The greatest number of passage attempts in one hour of the daily cycle totalled for all antennas ($n = 1101/17219 - 6.3\%$), were recorded just after dusk (18:00 - 19:00), while the least number of visits to the antennas in one hour ($n = 361 - 2.1\%$) occurred in the early morning (06:00 - 07:00; *Figure 6*). Between 16:00 and 20:00 (16.7% of diel time period) was the most active time for lamprey with 22.4% of all attempts ($n = 3863/17219$) recorded during this period. Calculated for the longest duration of daytime during the study (06:40, 16:53 [10 h 12 min daylight]), $n = 9196$ (53.4%) recordings were made during night time. As is also evident from *Figure 4* and *Table 1*, lamprey most frequently visited the fishway and tailrace (*Figure 6*).
